SECTION 32 PROGRAM  
STREAMBANK EROSION CONTROL,  
EVALUATION AND DEMONSTRATION  
WORK UNIT 2-EVALUATION OF EXISTING  
BANK PROTECTION

FIELD INSPECTION OF MORAMEAL REVETMENT  
ON THE RED RIVER

September 1979  
Inspection Report 7

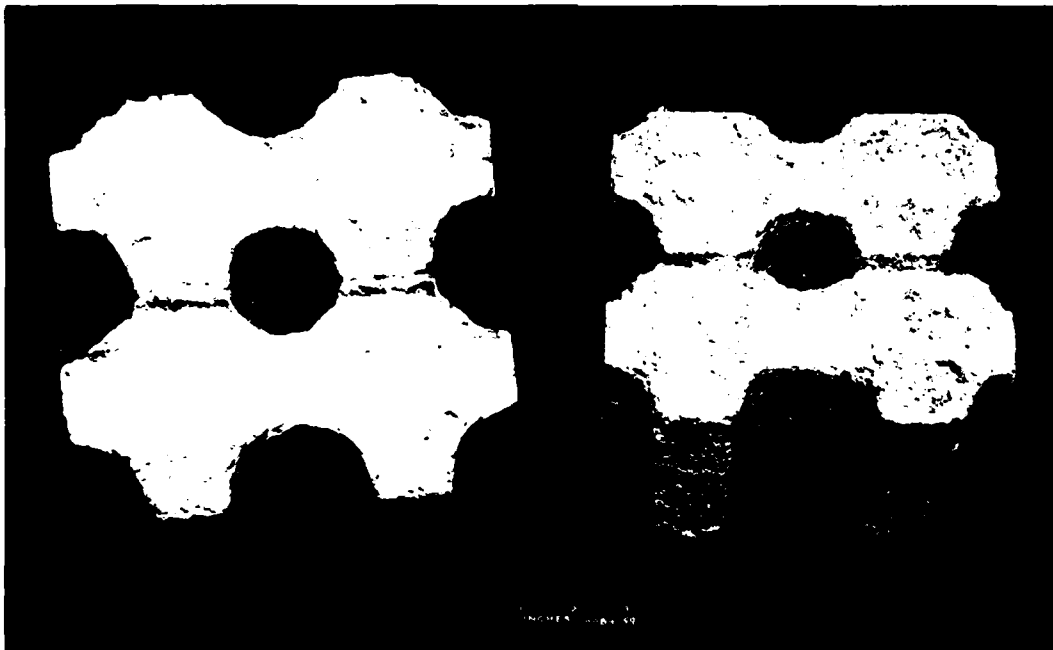
9. Gobi Blocks, manufactured by Erco Systems, Inc., New Orleans, Louisiana, were used as upper bank paving for Section B (sta 10+00 to 25+00). The Gobi Blocks are cellular concrete blocks cast using sand, gravel, 20 percent cement, and water. The mix is pressed into molds to form blocks (Figure 8). The blocks used under this contract were 8-in. square and 4 in. thick, weighing approximately 12.5 lb, with 232 blocks being required to cover a square (i.e. 100 sq ft). Four unskilled laborers placed an average of 6,000 to 7,000 blocks in a 10-hr day. Placement of the blocks was often difficult because of the variation in surface topography and the heavy rains that persisted during the installation. During the placement effort, there was some sliding of the blocks on the saturated bank. Figure 9 is a downstream view of Section B. A detailed view of the Gobi Block installation is provided in Figure 10; note that vegetation has begun to grow in the open areas within and between the blocks. This revetment section has never been subject to attack by high-velocity flow or wave action. Several small depressions were noted during the inspection visit (Figure 11), where the blocks have settled as a result of leaching of underlying bank

Figure 8. Gobi Blocks
